New York City Transit

CULVER LINE REHABILITATION

**PRESENTATION TO COMMUNITY BOARD 6
TRANSPORTATION COMMITTEE
NOVEMBER 15, 2007**

Structural rehabilitation of mile-long Culver Viaduct

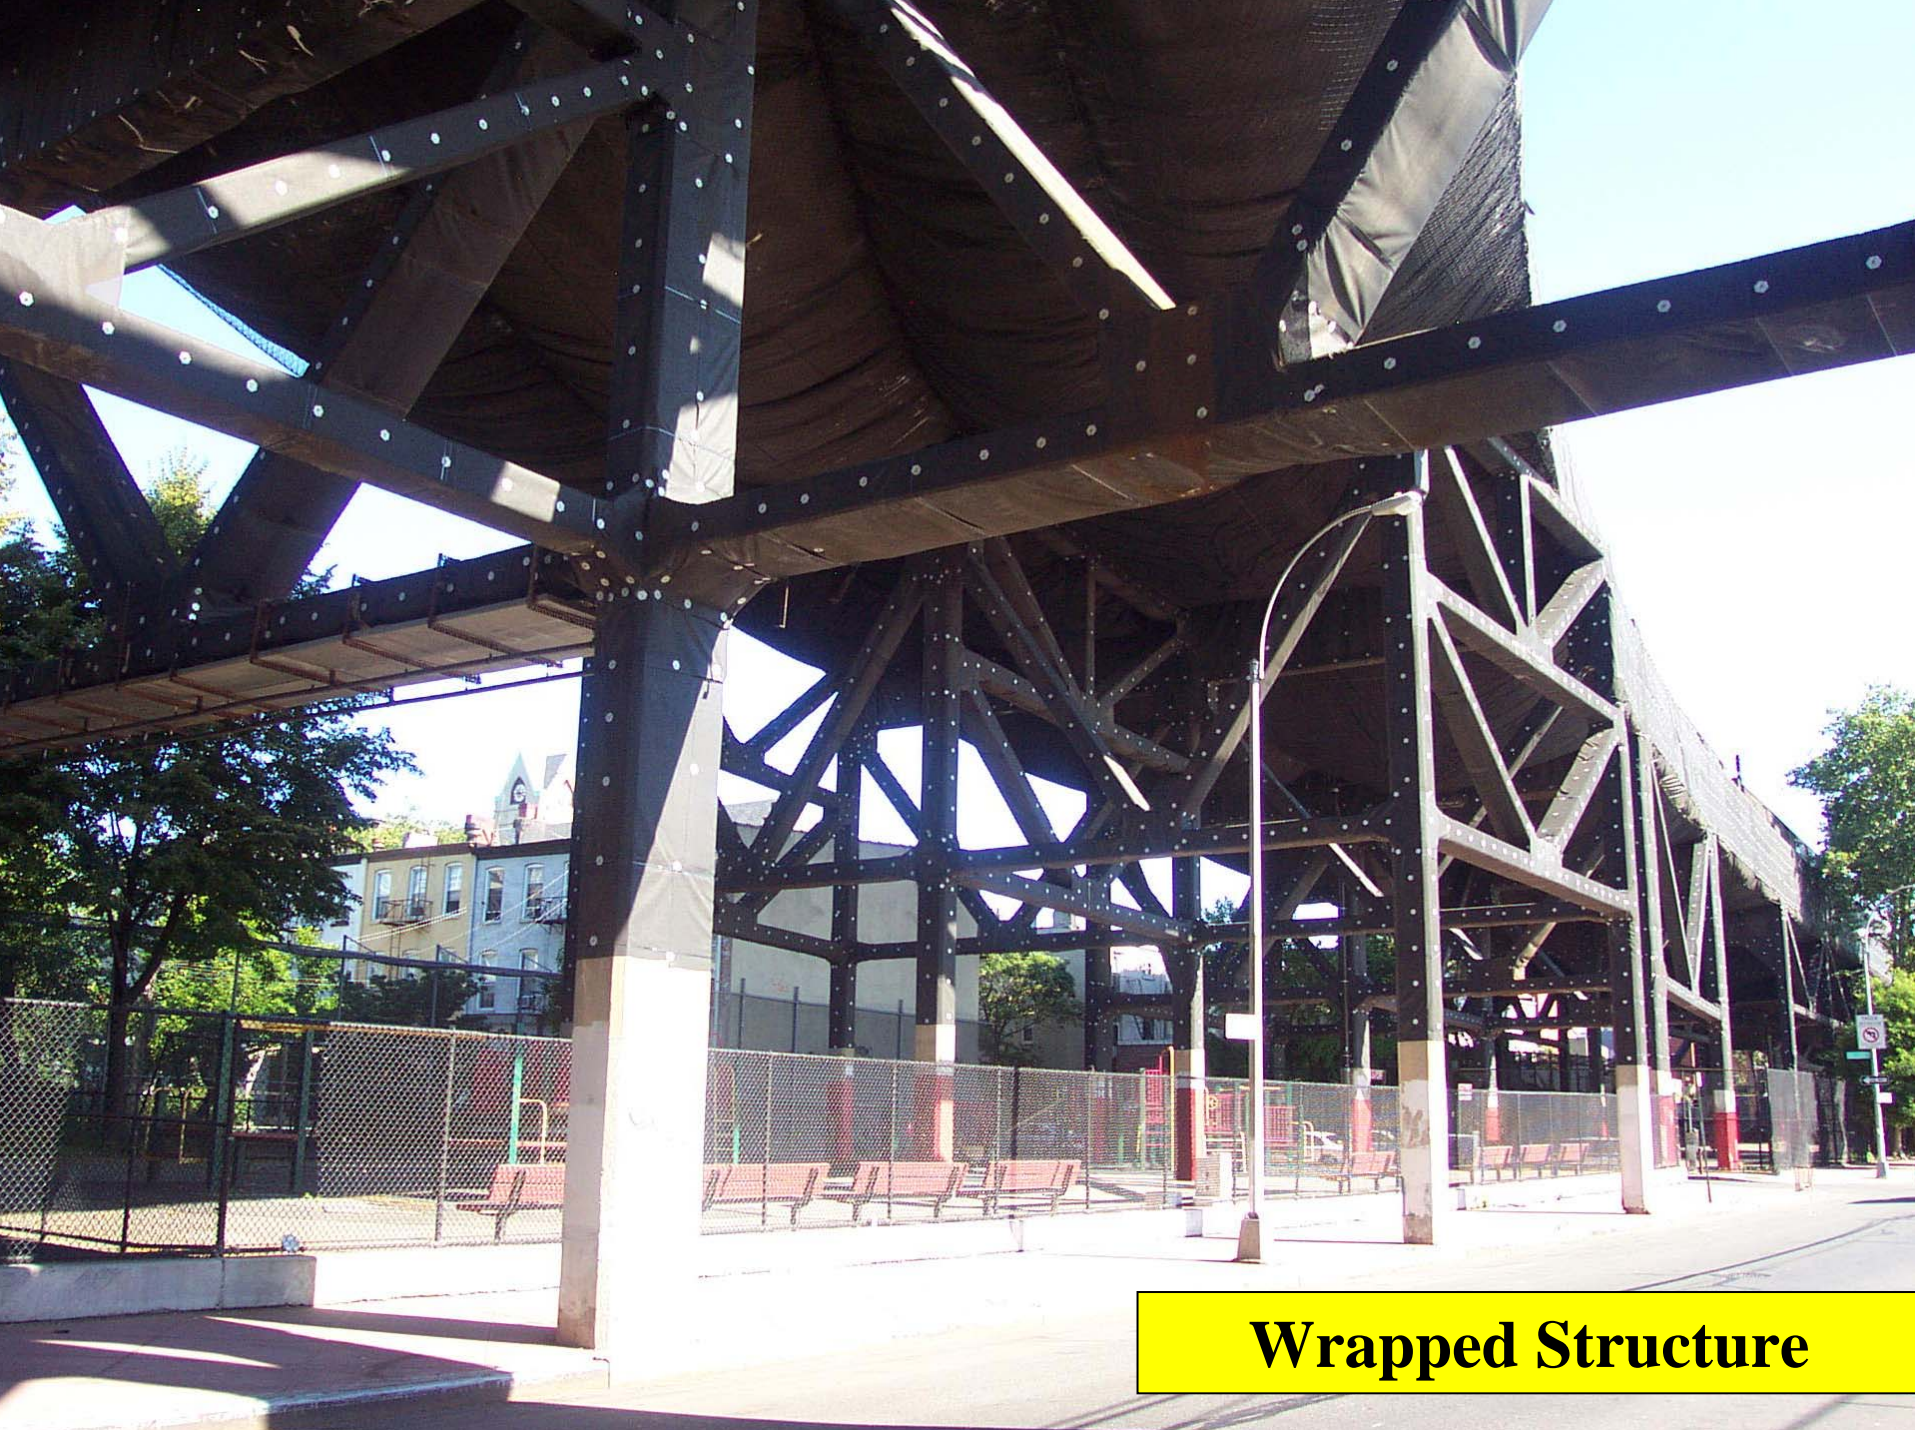
Failed deck waterproofing - Concrete spalling and exposed steel

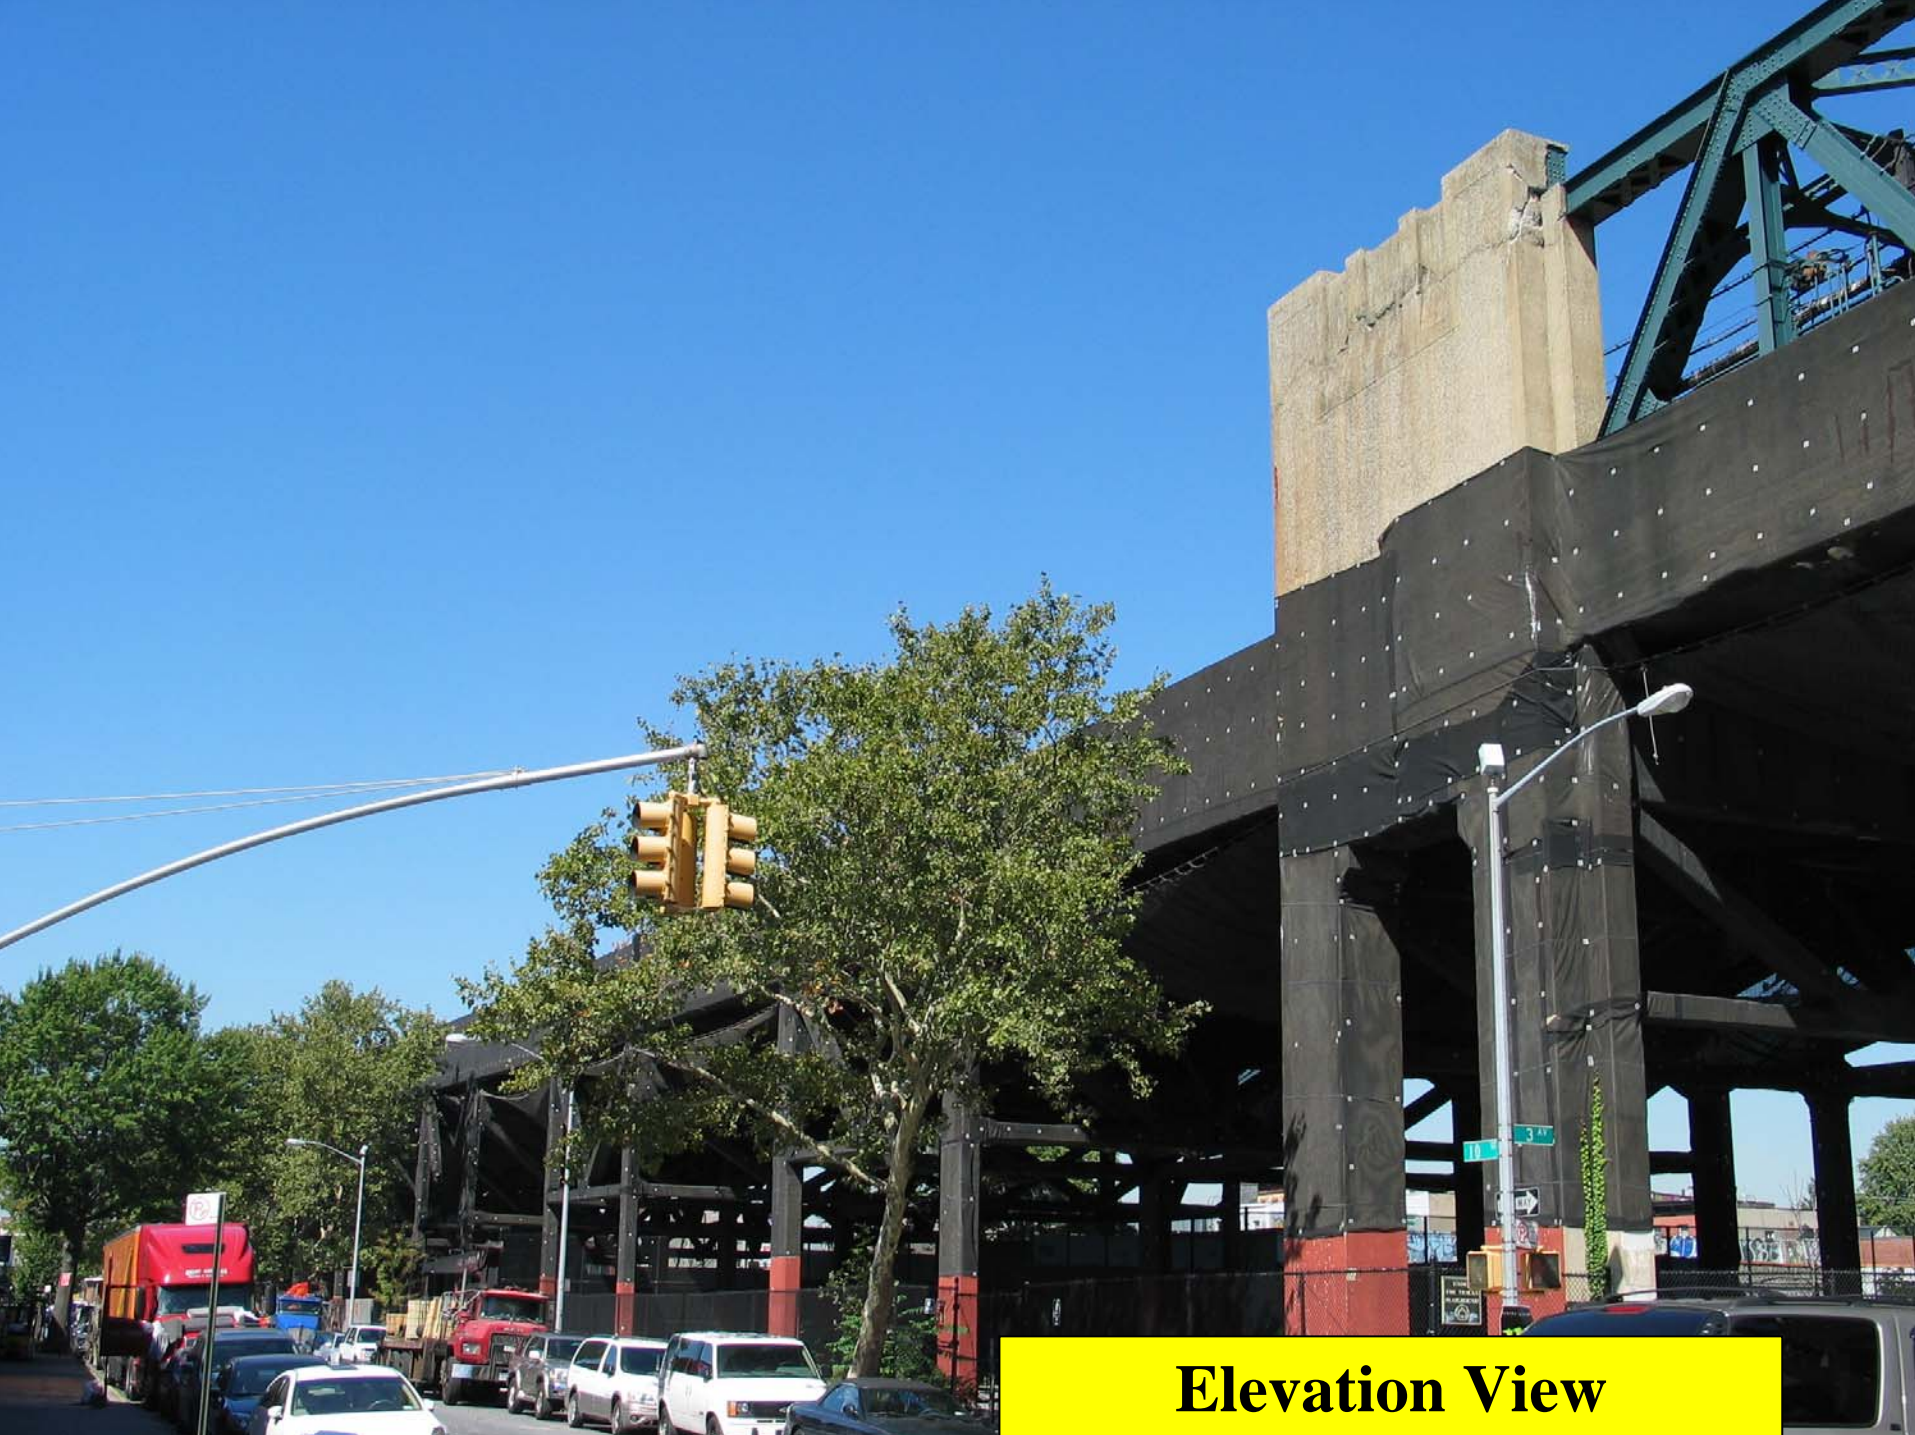
Wrapped Structure

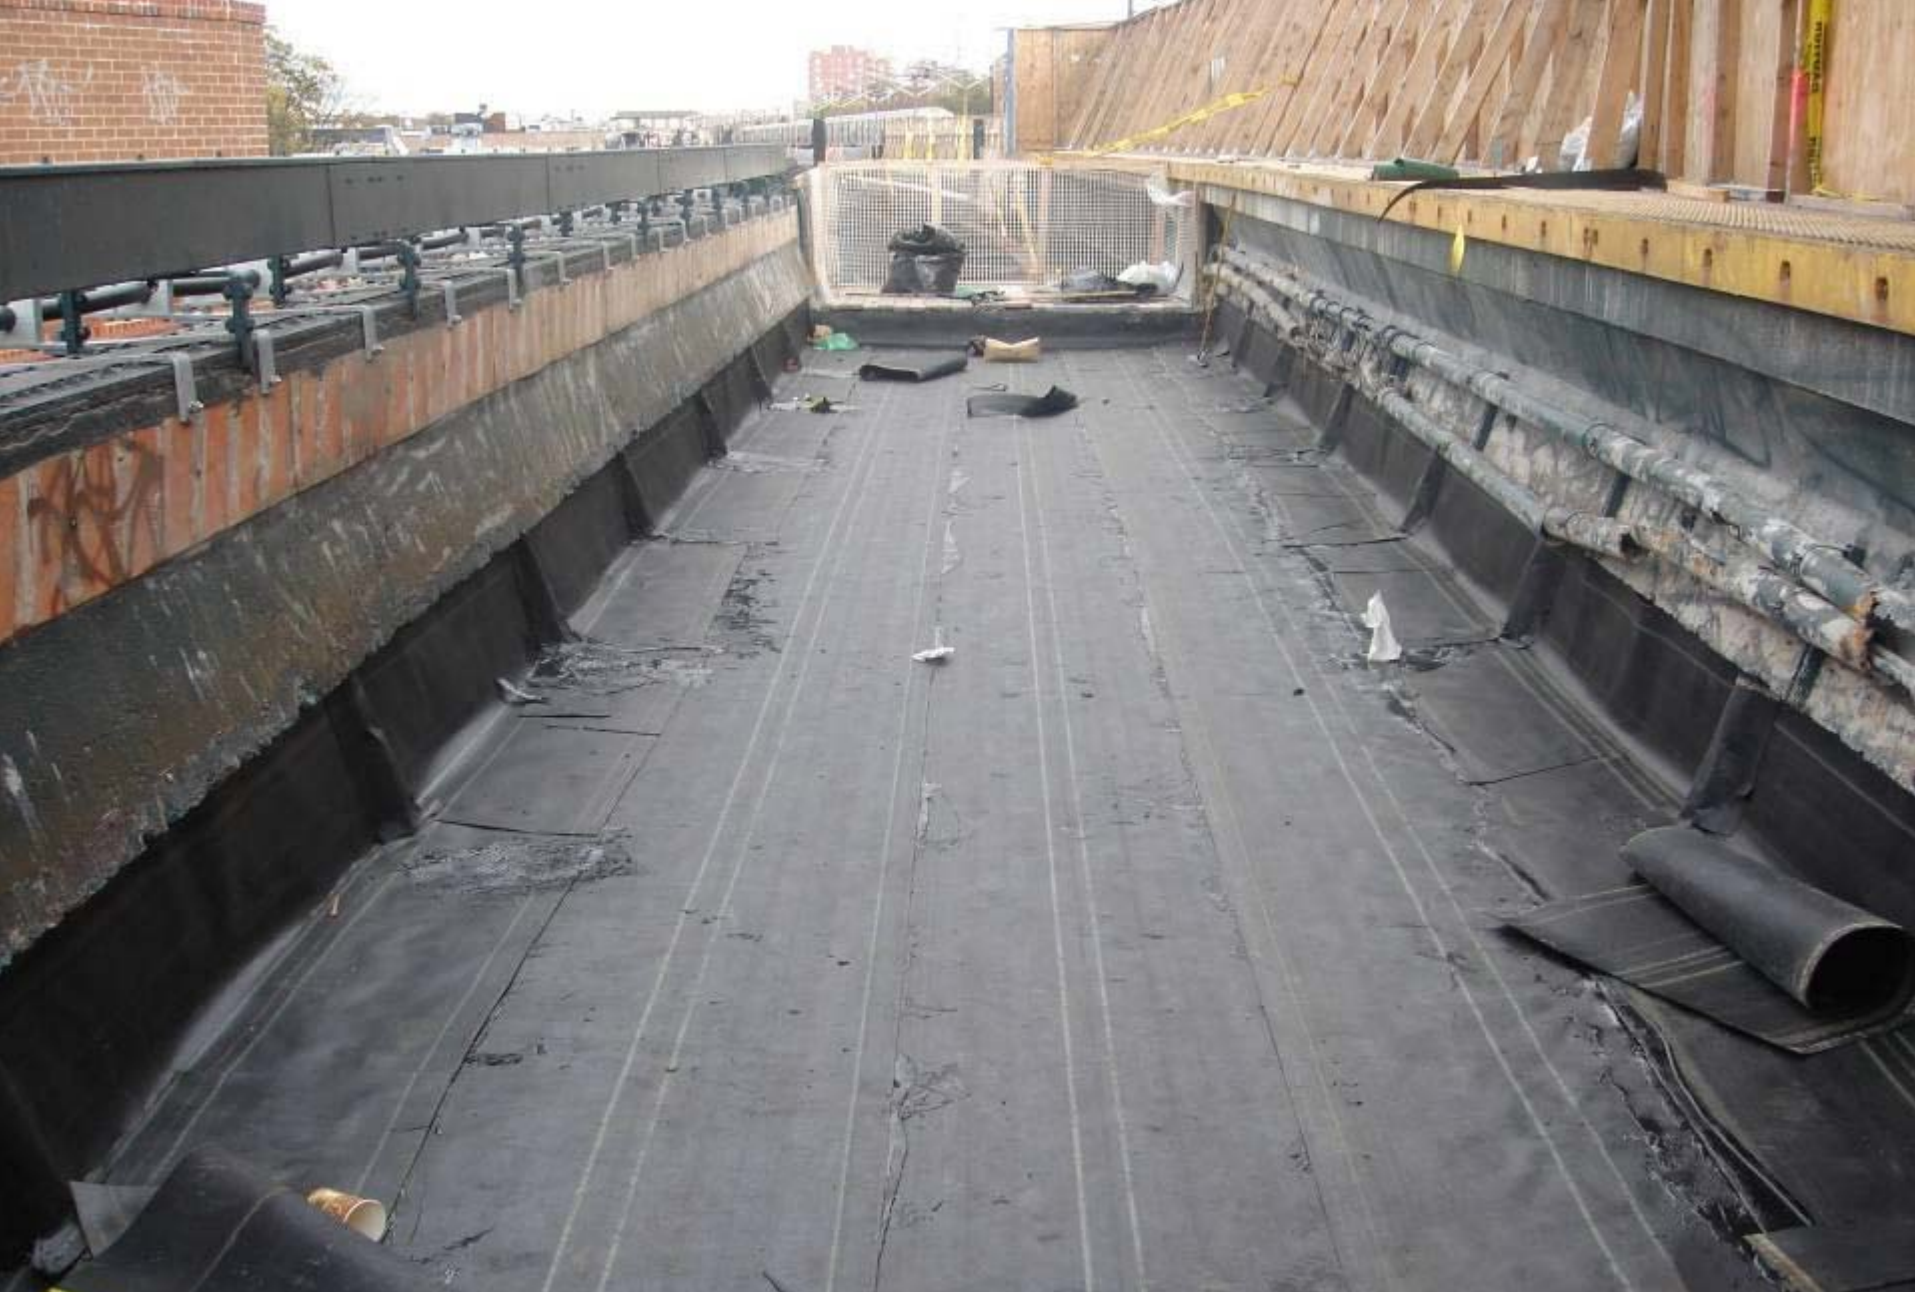
Installation of Deck Slab at Ocean Pkwy.

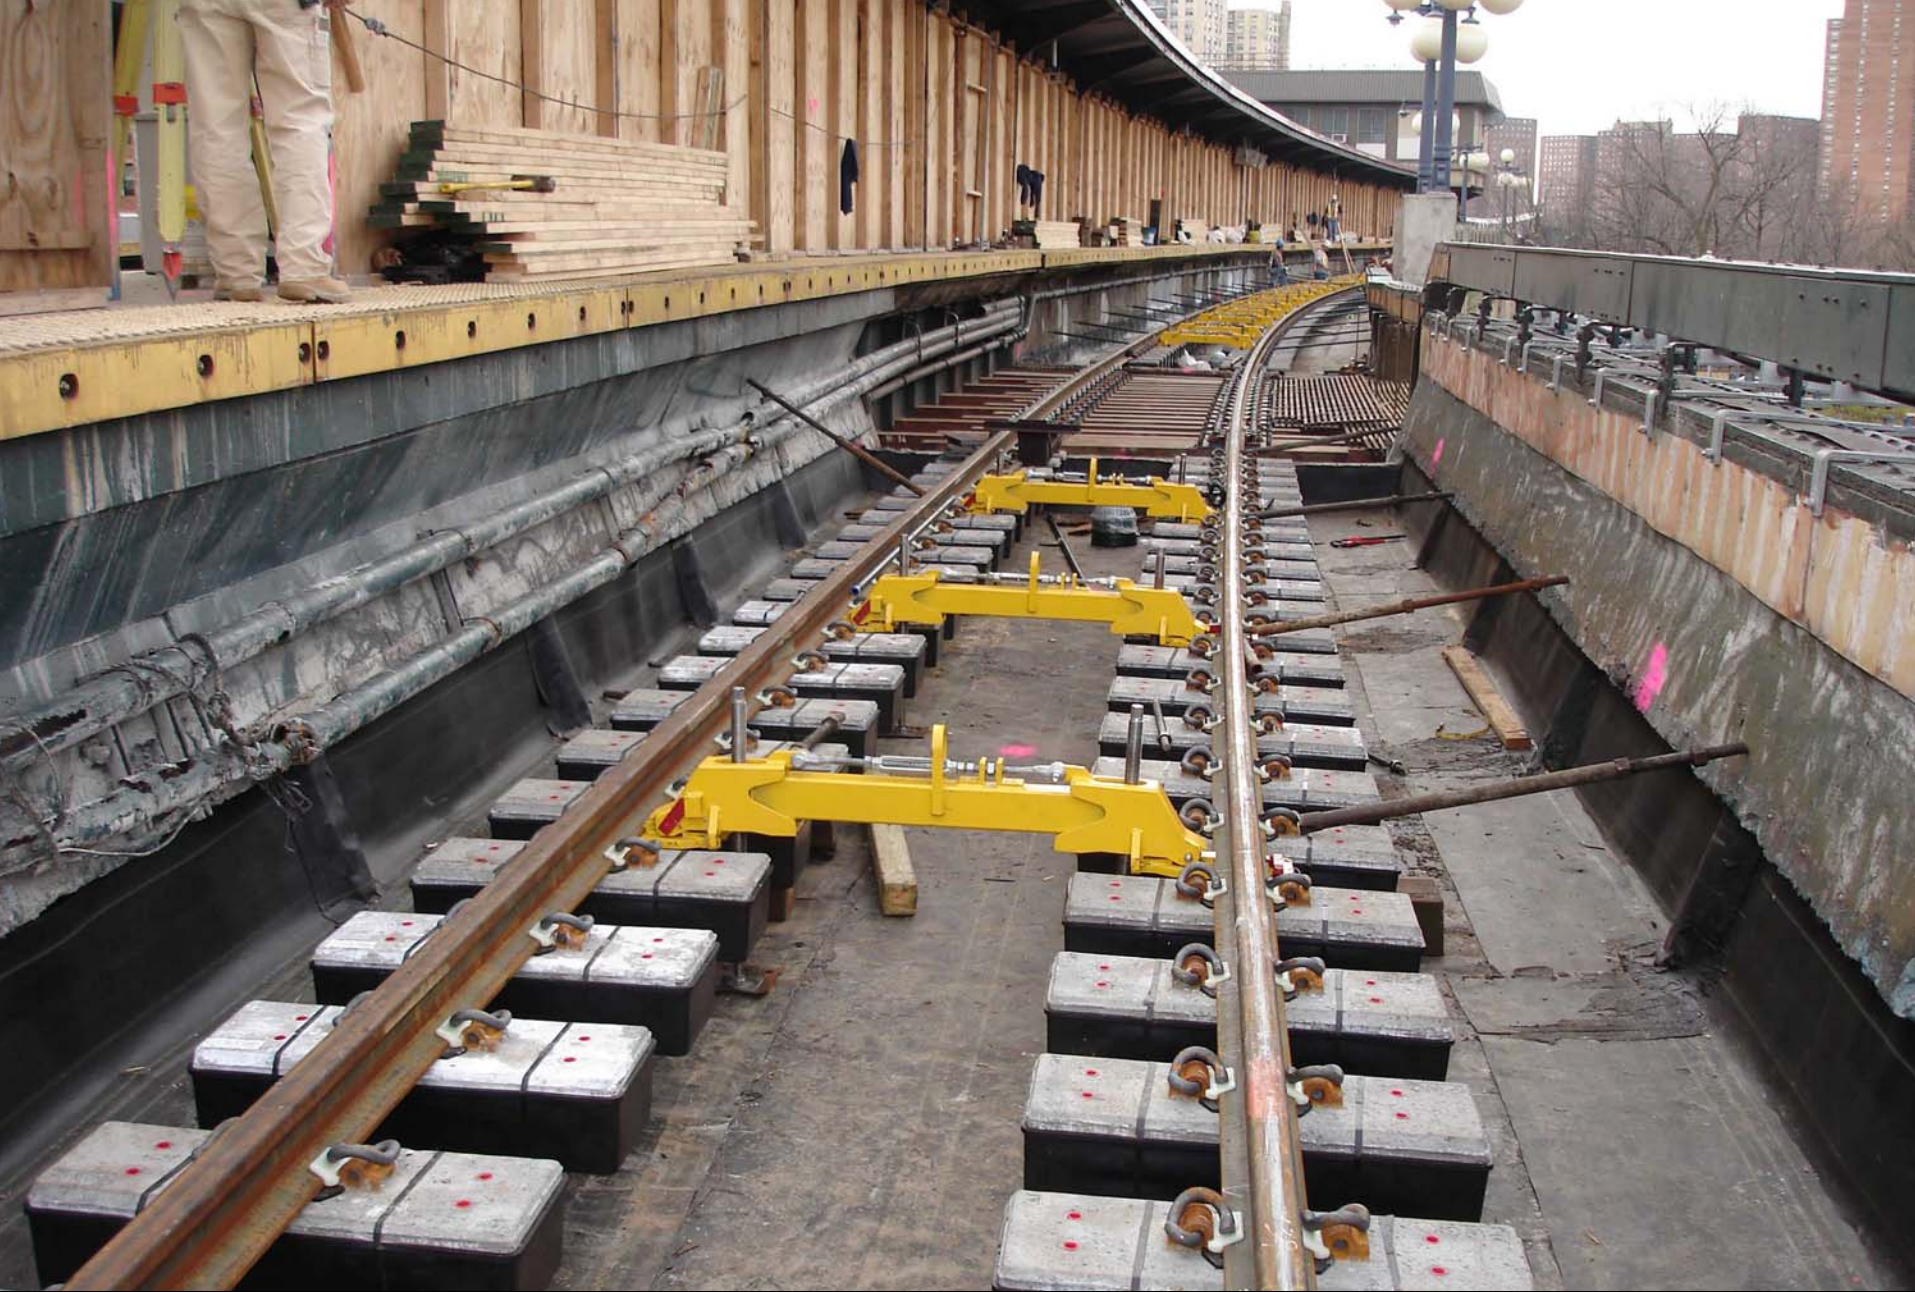
Installation of Deck Waterproofing at Ocean Pkwy. Station

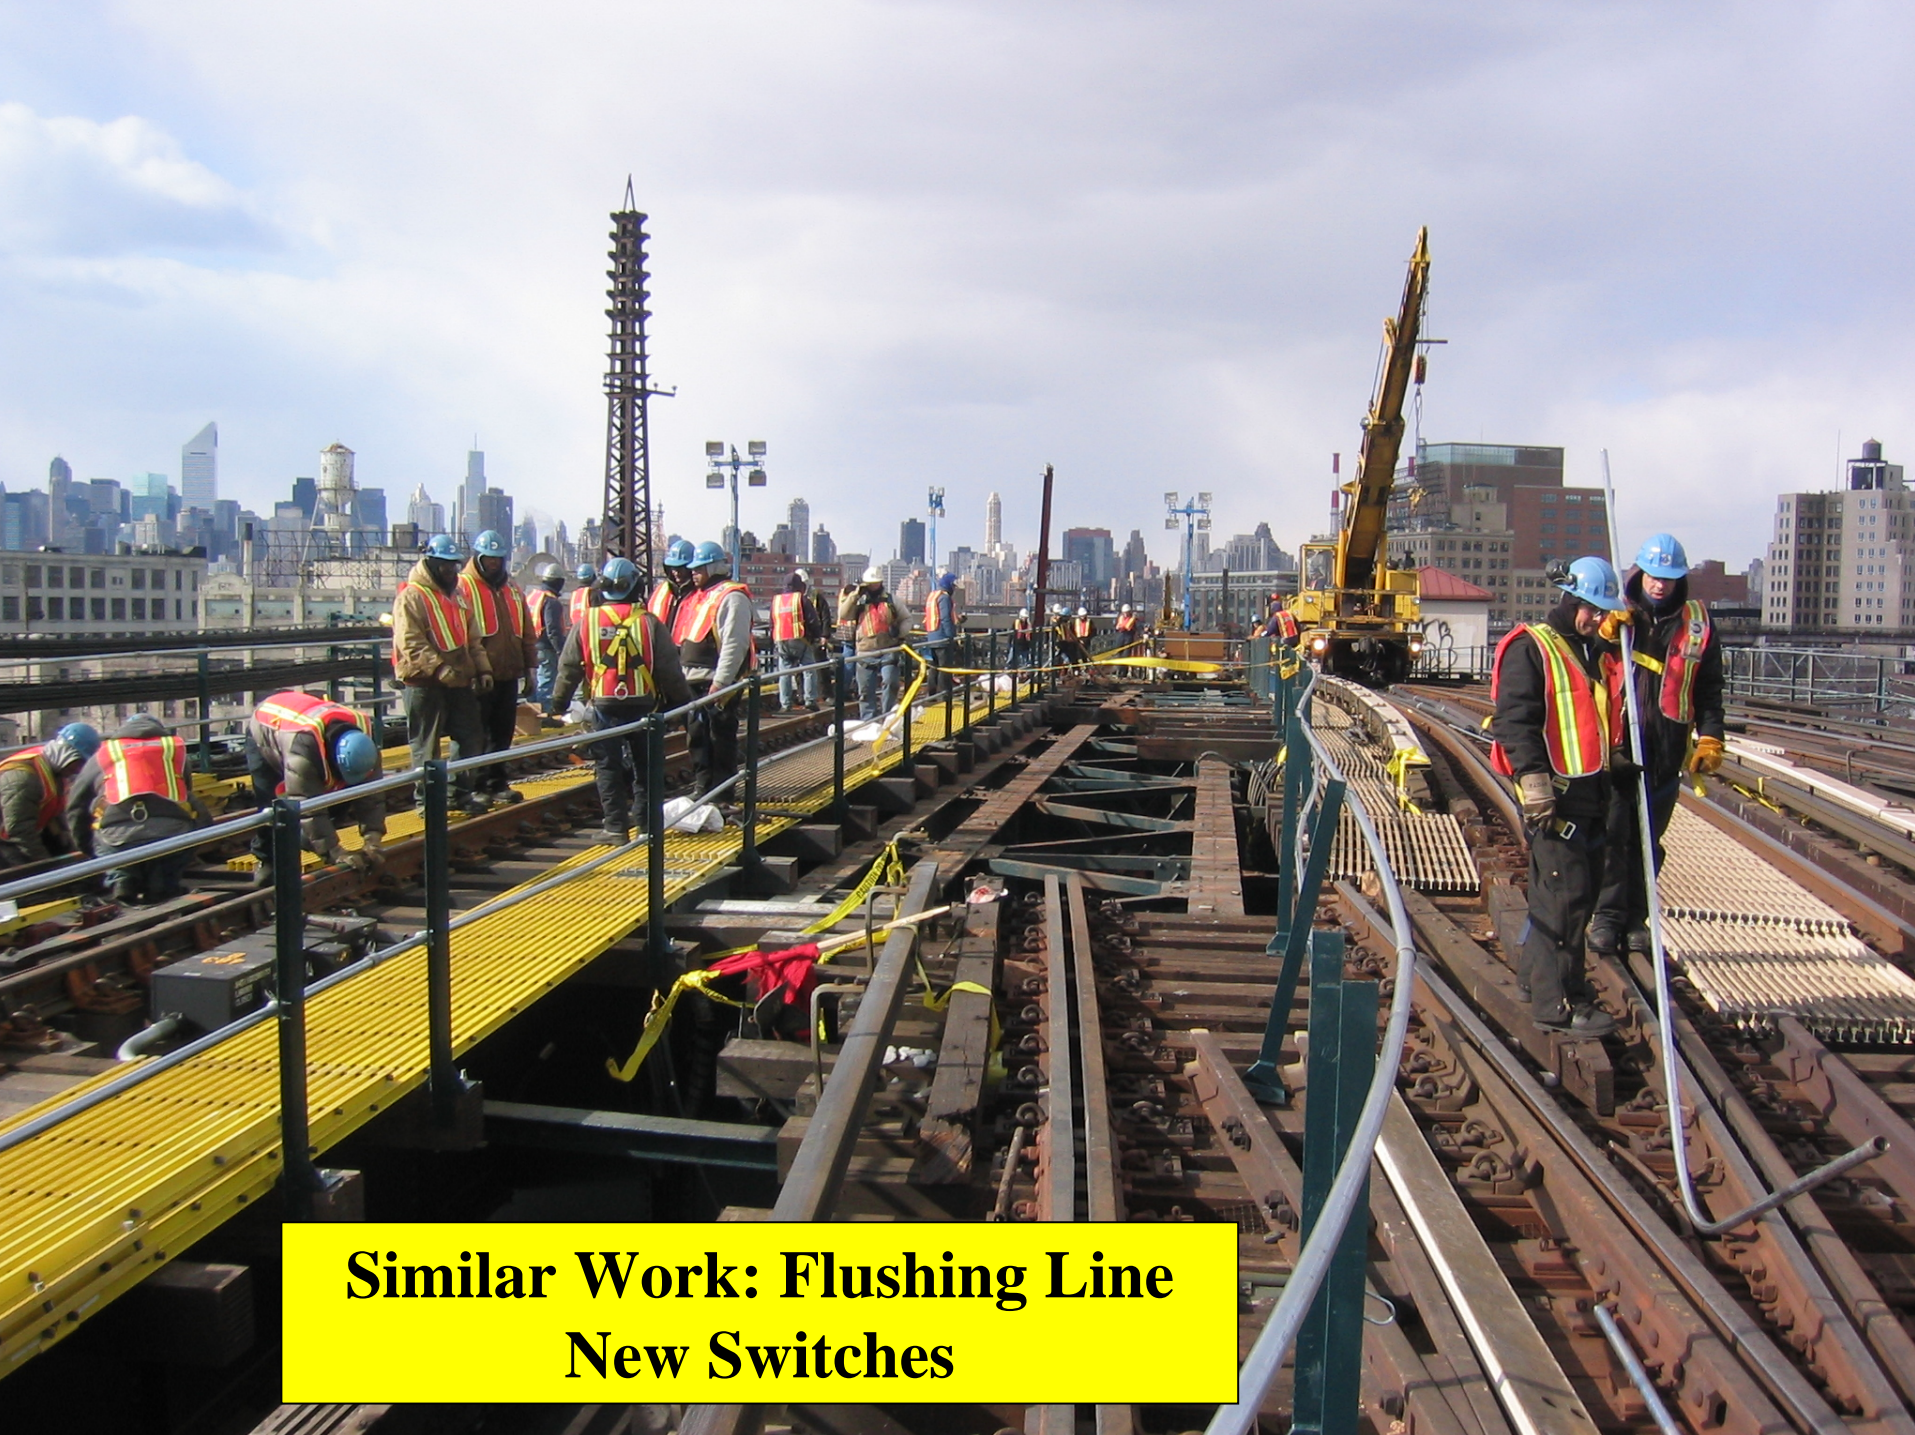
Installation of New Low-Vibration Track at Ocean Pkwy. Station

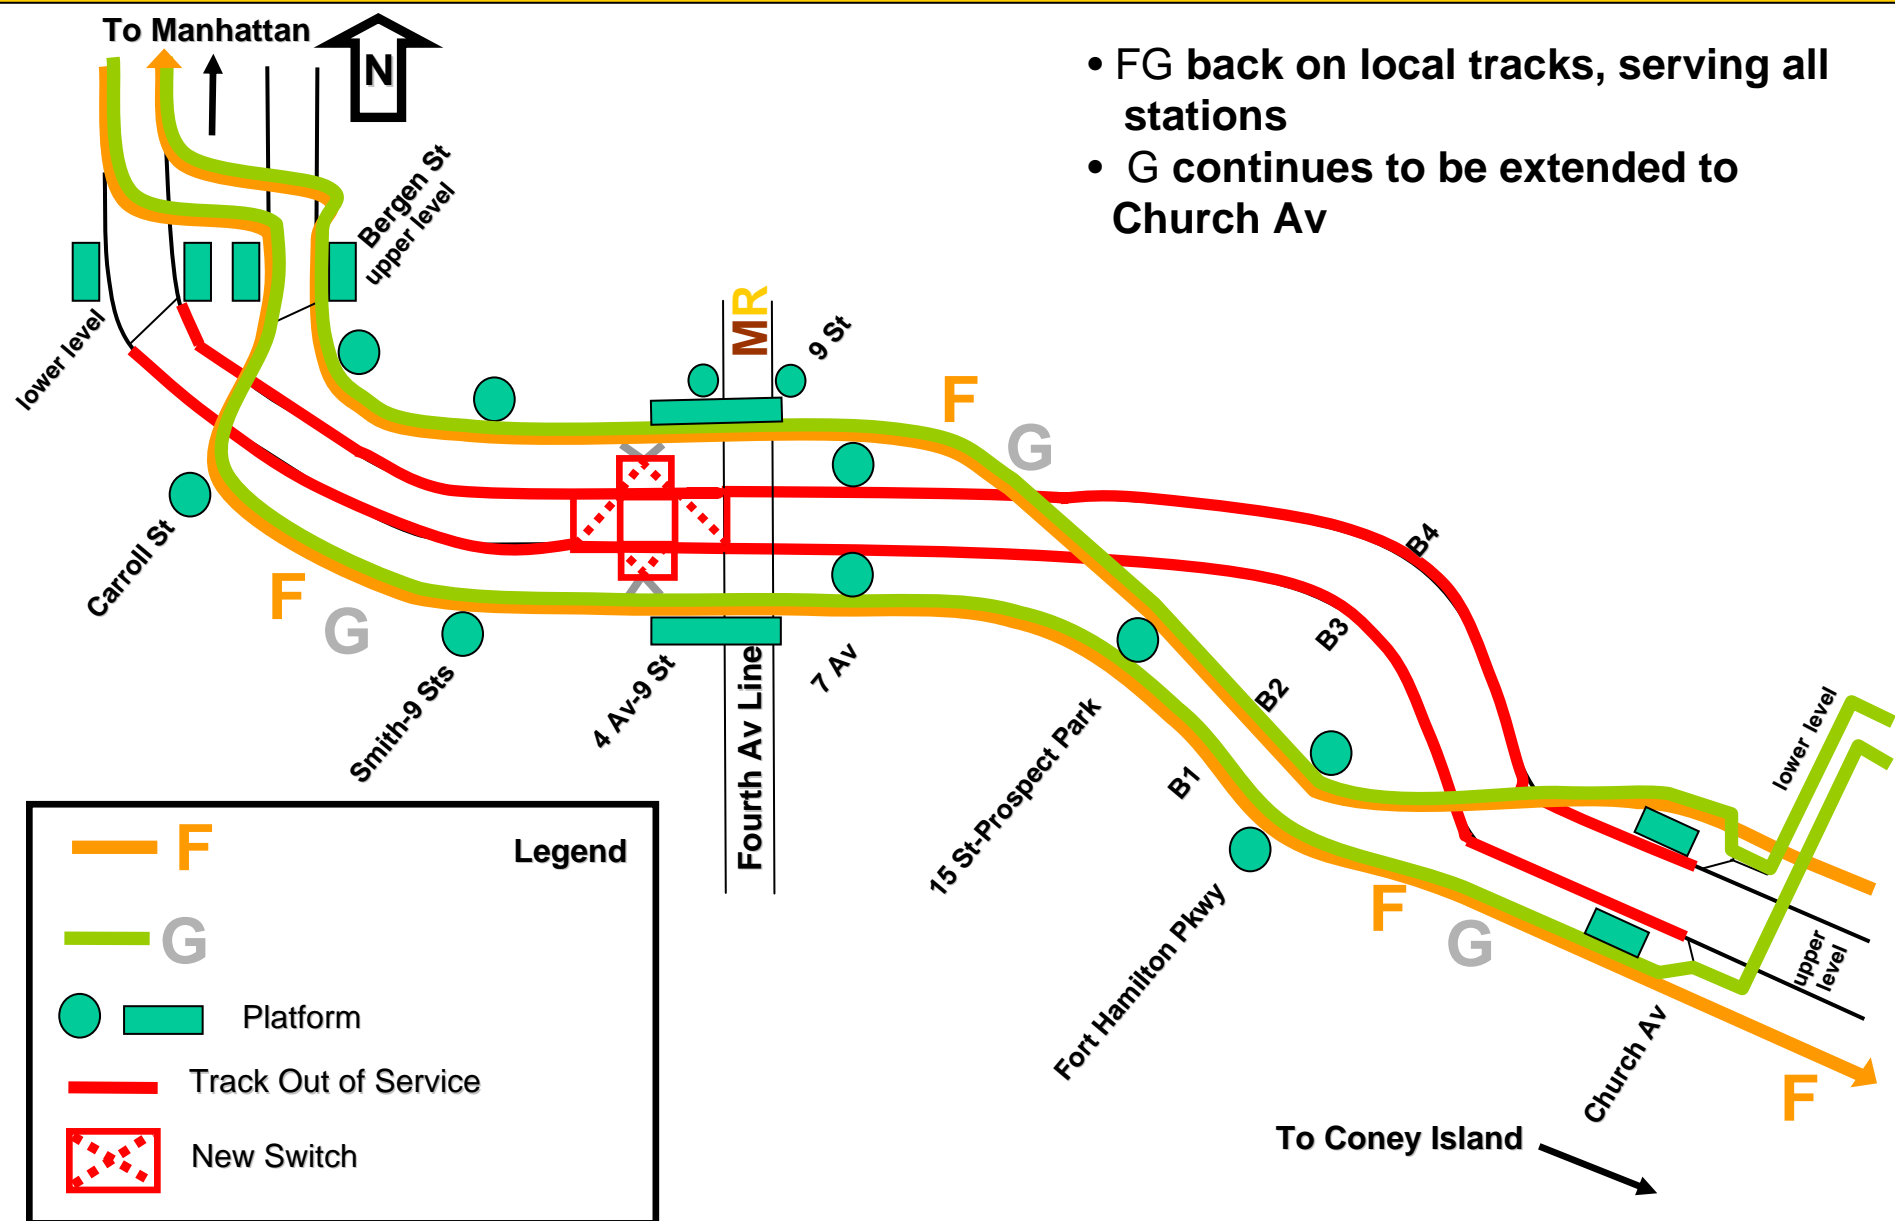
Culver Viaduct Phase 4

3 Months
